## Footpath 20 (Public)– between the former railway bridge at Western Torrs and Rough Torrs down to the road bridge at Puslinch

### Problem

### Aim of the Scheme

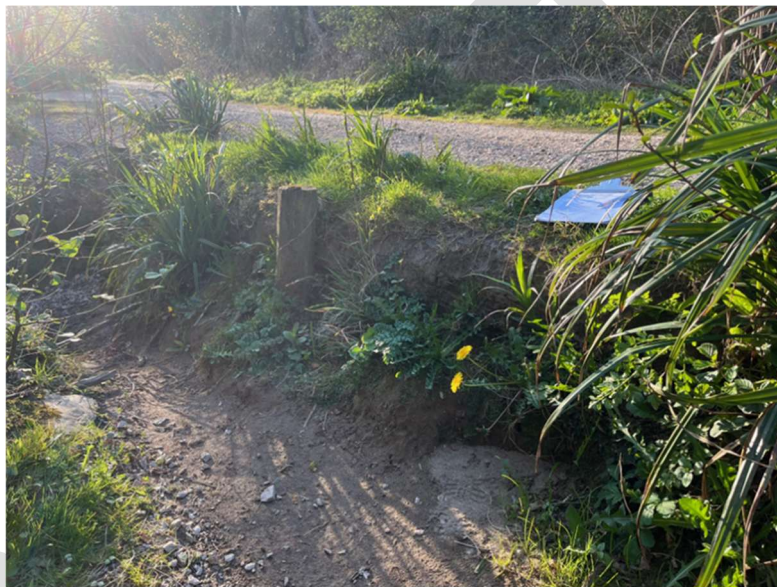
Some work has previously been done to support the banks; examples of this is shown below. It is proposed that this style of log faced support is used on stretches of the whole river between the two stars on the location map. It will not necessarily be continuous – areas that are suffering erosion will be supported in this way, to stabilise the bank and provide a stable base for trees and plants to grow.

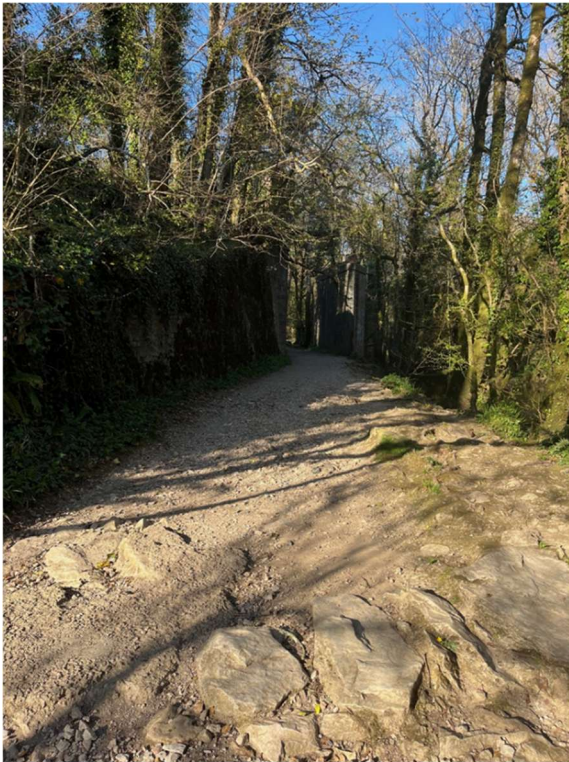
Site of proposed concrete path – 50 metres long.

(view looking North East)

The path from the Western Torrs railway bridge down to the first existing concrete strip (looking West). This stretch will be 50 meters. This path will be 2.5 metres wide and 100 mm deep. This area is very vulnerable to erosion and seen from vehicular access point of view will not be possible if nothing is done to improve/maintain the path.

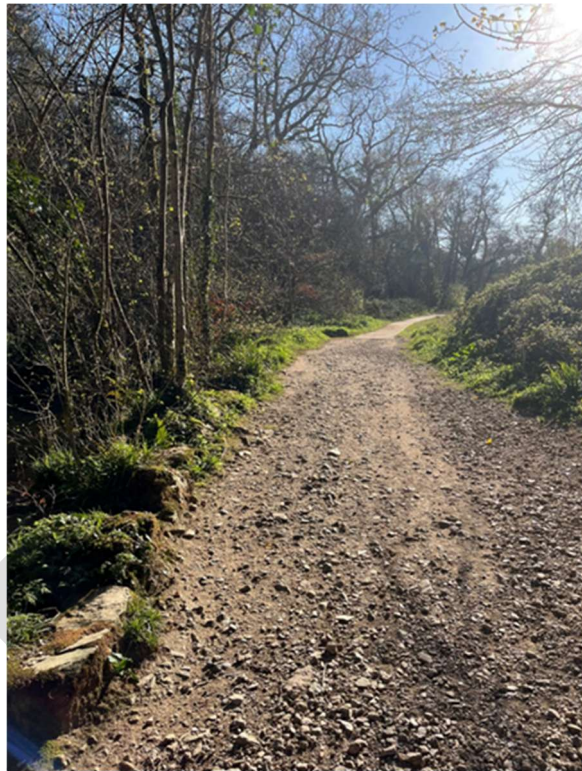
(view looking South West – existing concrete path visible in distance)

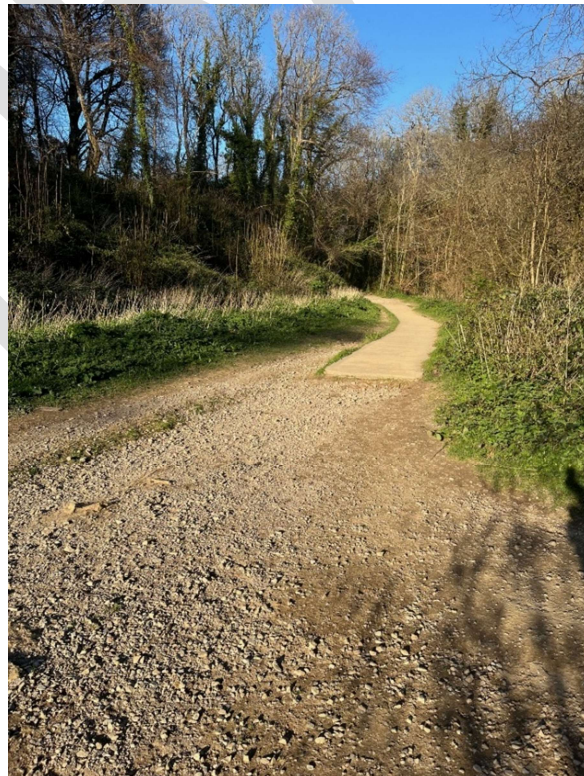
**An example of the existing concrete path that will be extended.**

A further stretch of concrete, 40 metres long and approximately 1.4 metres wide will be laid to link the two existing stretches of concrete path.

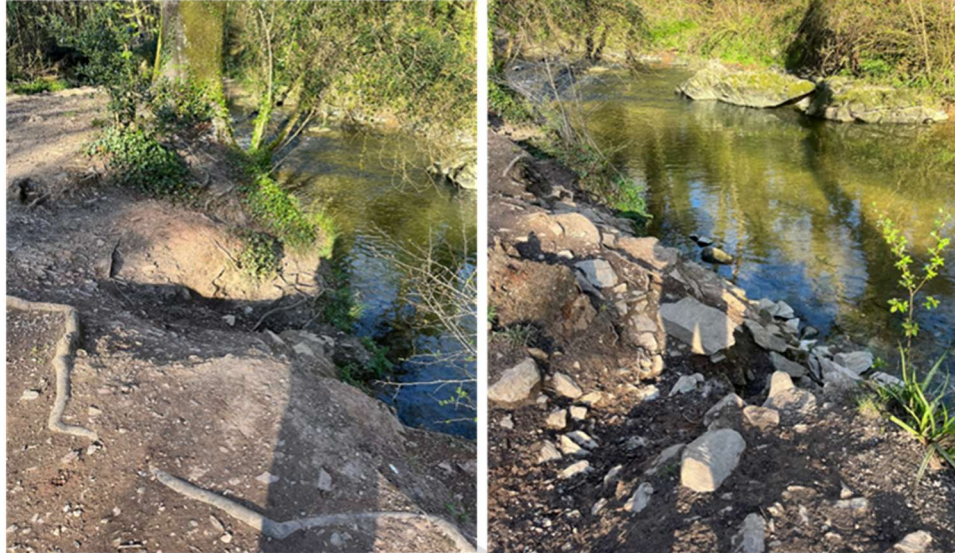
Example of the bank erosion, that is being accelerated by dogs jumping into the river and scrambling out. Here the bank will be faced with logs and built up, to prevent further erosion.

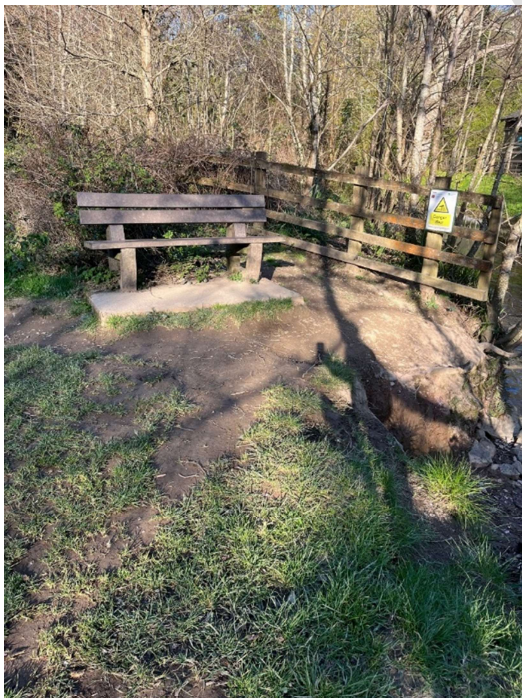
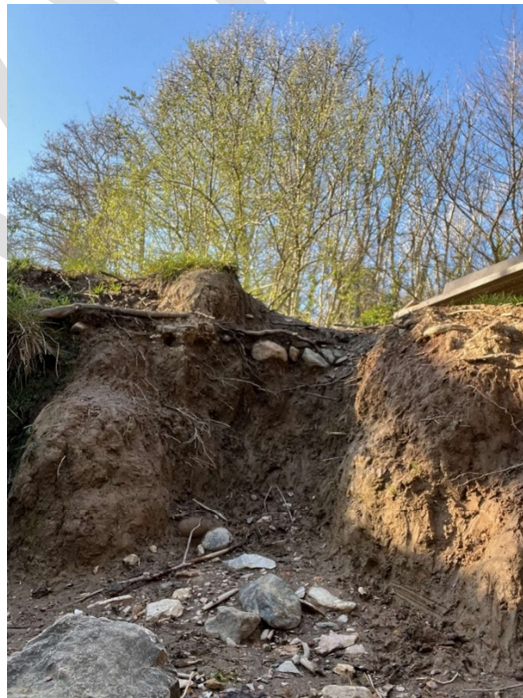
**The following photographs show some of the problems that this scheme is trying address**
